Laser Bore Inspection System "ANALYZER3"

# Sample Tests and Case Studies

Real inspection data and evaluation results using actual workpieces.

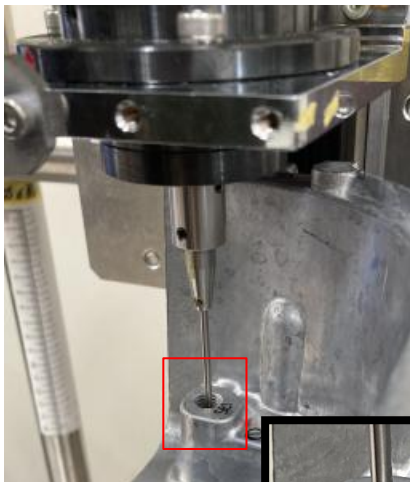
## ANALYZER3 Inspection Scene

With a  $\varnothing 2.3$  mm probe shaft, ANALYZER3 can capture images inside M6 tapped holes.

※Available for tapped holes starting from M4 (minimum).

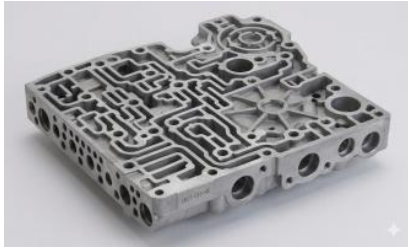
# Valve Body

The valve body is a critical component that controls hydraulic fluid flow inside the transmission to manage gear shifting. It contains numerous oil passages, deep holes exceeding 100 mm, and intersecting holes, making internal visual inspection difficult. It is one of the most common workpieces inspected using ANALYZER3.
